MTL TR 90-44

FAILURE ANALYSIS OF A MAIN ROTOR PITCH HORN BOLT LOCATED ON THE AH-1 COBRA HELICOPTER

VICTOR K. CHAMPAGNE, Jr.
MATERIALS TESTING AND EVALUATION BRANCH

September 1990

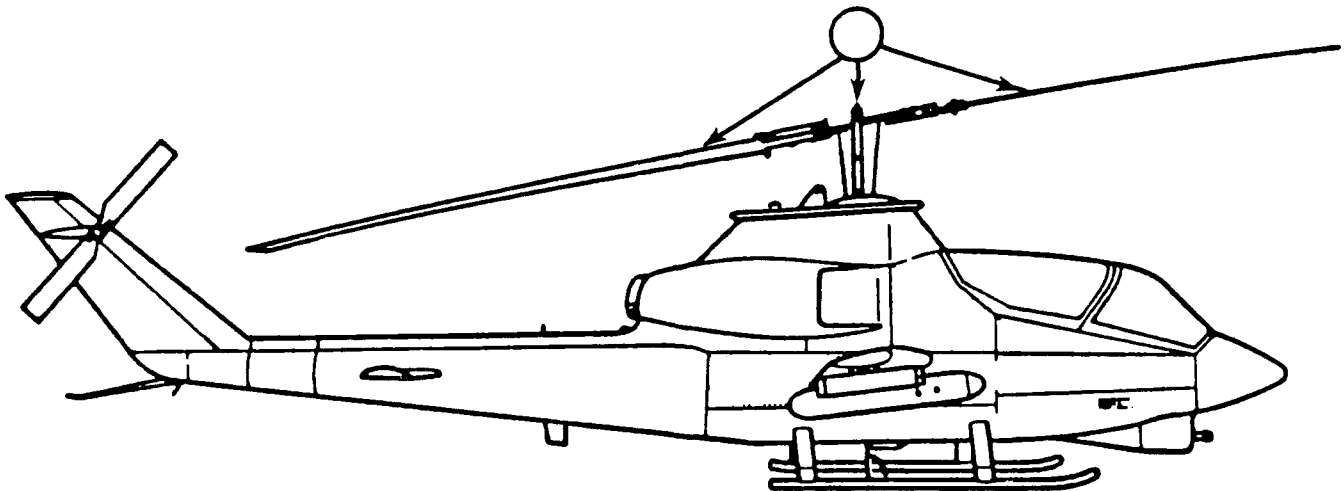
Figure 1. Schematic of the AH-1 Cobra Helicopter showing the general location of the pitch horn bolt.

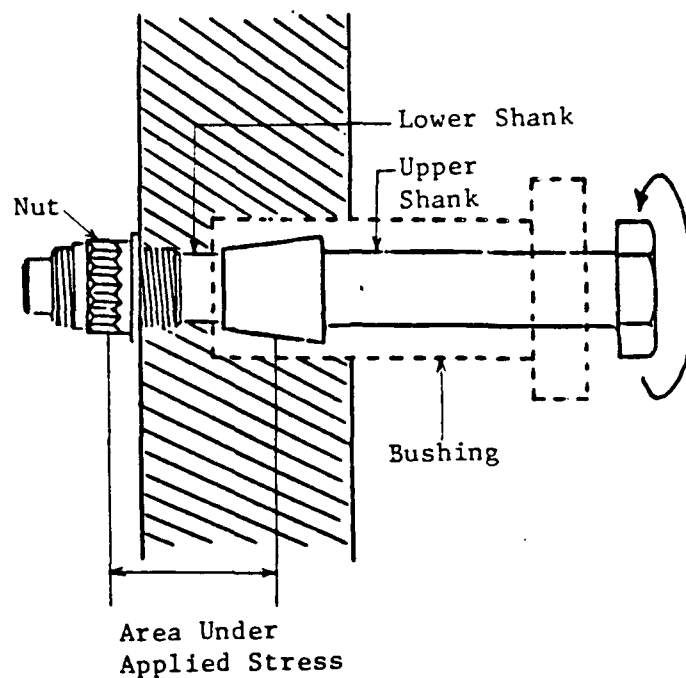
The Aviation Systems Command (AVSCOM) Depot Engineering and Reliability Centered Maintenance Support Office located at Corpus Christi Army Depot requested that MTL perform a failure analysis of the pitch horn bolt which had failed during service. The failure was discovered upon disassembly of the component during a maintenance procedure. The bolt is part of the Main Rotor Hub Assembly located on the AH-1 Cobra Helicopter, as depicted in Figure 1. The general arrangement of the assembly components relative to the main rotor system can be viewed in detail in an enlarged illustration of this area contained in Figure 2. The torque requirements for the bolt under investigation (1000 to 1200 in.-lb) along with those for adjacent fasteners have been listed on the schematic. Two pitch horn bolts are inserted into the pitch horn assembly which is a portion of the mechanism that controls the pitch of the helicopter blades during flight, as shown in Figure 3. When one of these bolts fails in service, the load is transferred to the remaining component still intact which drastically reduces its fatigue life. Failure of both pitch horn bolts will prevent the pilot from properly controlling the helicopter during flight and when landing. It is important to note that the only area under applied stress after installation is located beneath the upper shank of the bolt. There is actually a space between the head of the bolt and the bushing, as illustrated in Figure 4, indicating the absence of any externally applied loads in this region.

Figure 4. Schematic showing installation of the bolt during service.

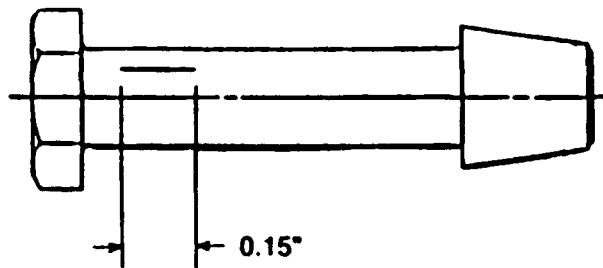
A Mitutoyo Surftest Analyzer was used to measure the surface finish of the pitch horn bolt. The instrument was calibrated with a Bendix Precision Roughness Standard (Model No. 25A). A total of three measurements were taken 120° apart from each other along the upper shank of the component, within regions that had not experienced wear during service, as shown in Figure 12. Further measurements of other surfaces could not be performed because of excessive service-related wear. Bell Helicopter Drawing No. 209-010-112 specified the surface finish of the bolt to be 125 microinches (u in.) RMS except for two areas where the finish was required to be 63 (u in.), as identified in Figure 13. For each measurement, five consecutive sample lengths of 0.03 in., were taken in a line parallel to the bolt's center-line to arrive at a representative RMS value. The three results of 68 u in., 64 u in., and a 70 u in. were within the drawing requirements. A representative plot of the topography traversed by the profilometer's needle during each measurement is shown in Figure 14. The data obtained from this test is listed in Table 1.

Figure 12. Schematic showing where surface profile readings were taken. Three measurements were taken along the same general portion of the bolt, approximately 120° from each other.

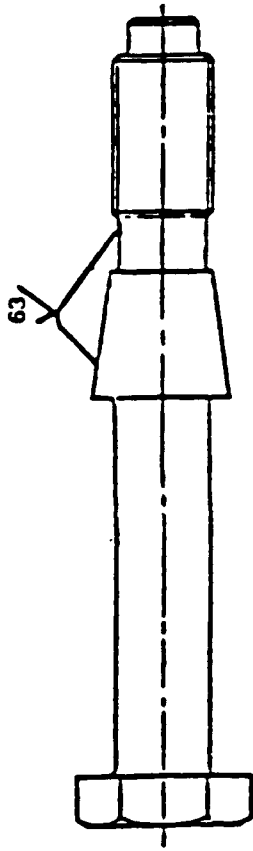
Figure 13. Schematic of bolt design. Surface finish is specified as 125 microinches, except the two areas indicated where the finish is 63 microinches.

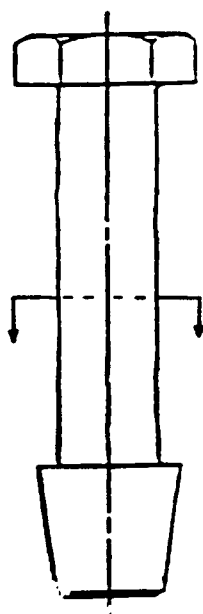
The engineering drawing of the pitch horn bolt specified a minimum tensile strength range of 180 to 200 ksi which converted to an approximate hardness level of Rc 39-43. Macrohardness measurements were taken on transverse cross sections of the bolt above the conical region, as shown schematically in Figures 15 and 16. The results of this test did not reveal evidence of any regions that displayed unusually higher or lower degrees of hardness, which may occur if the material had been locally heated. The average value of all the measurements taken did show that the material was hardened to the upper limit of the acceptable range (refer to Table 3).

Figure 15. Indicates the area where the bolt was sectioned for hardness testing.
